NATIONAL ADVISORY COMMITTEE FOR AERONAUTICS

WARTIME REPORT

MEASUREMENTS IN FLIGHT OF THE STABILITY, LATERAL-
CONTROL, AND STALLING CHARACTERISTICS OF AN AIRPLANE
EQUIPPED WITH FULL-SPAN ZAP FLAPS AND
SPOILER-TYPE AILERONS

MEMORANDUM REPORT

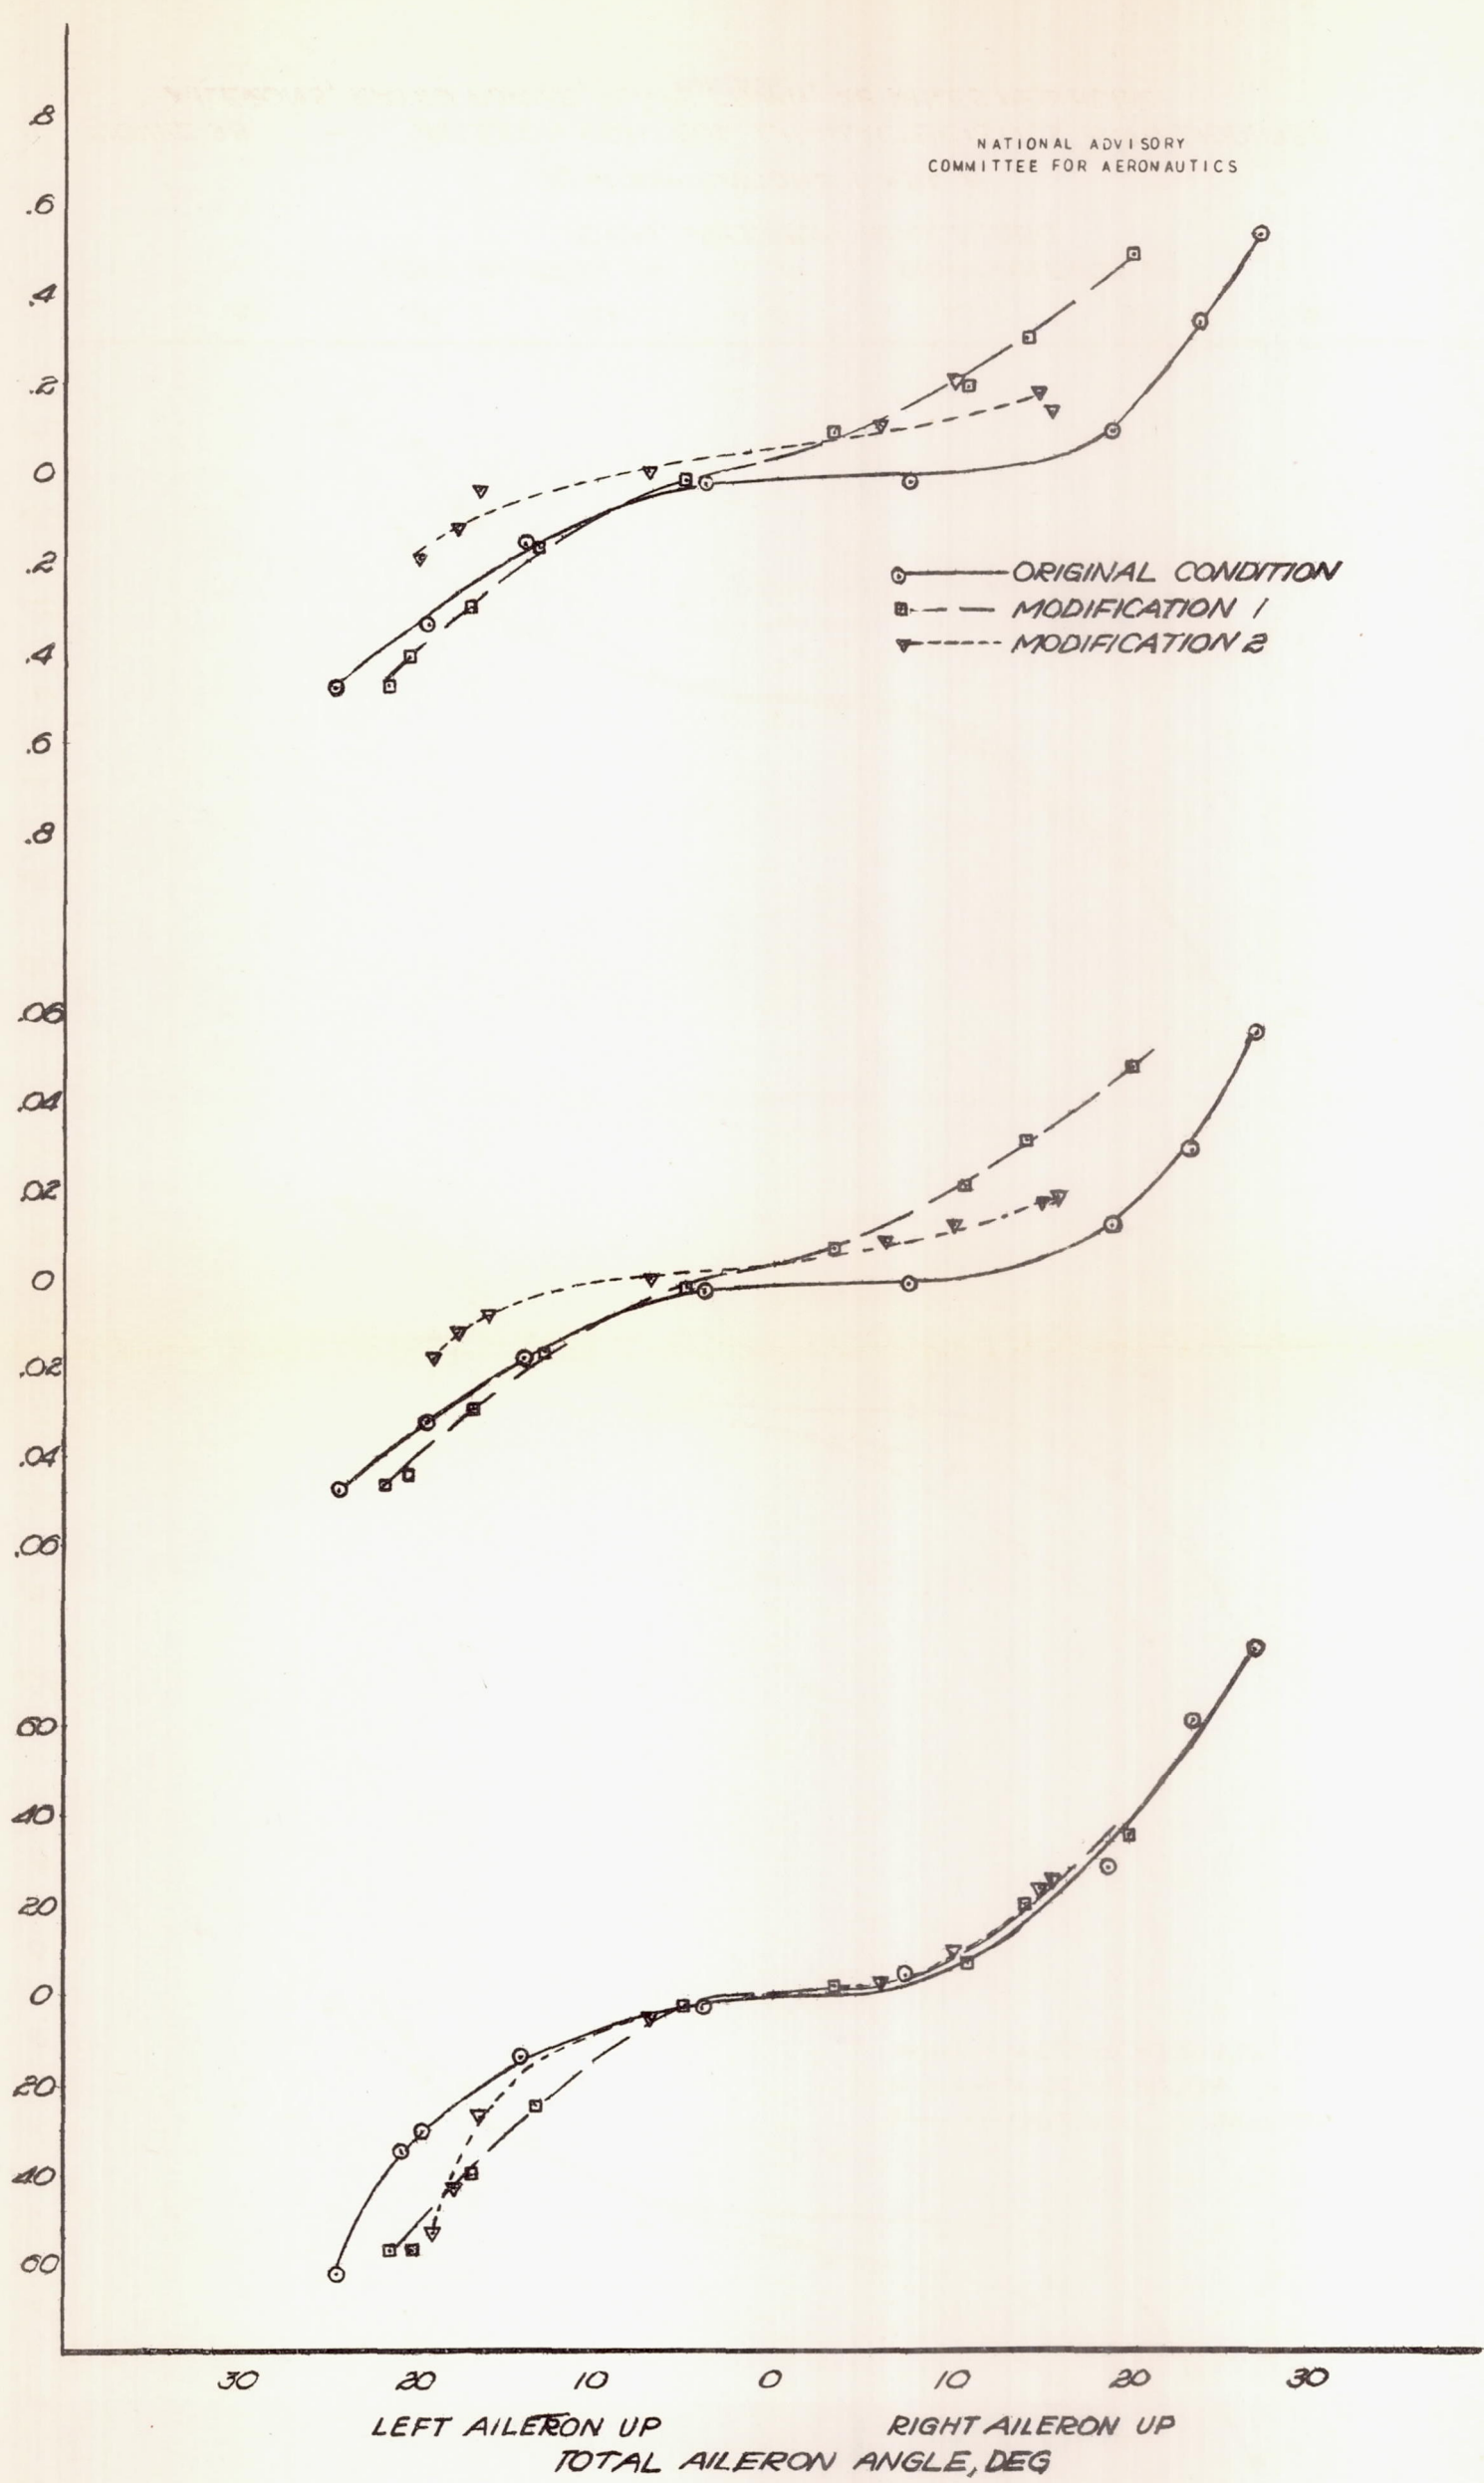
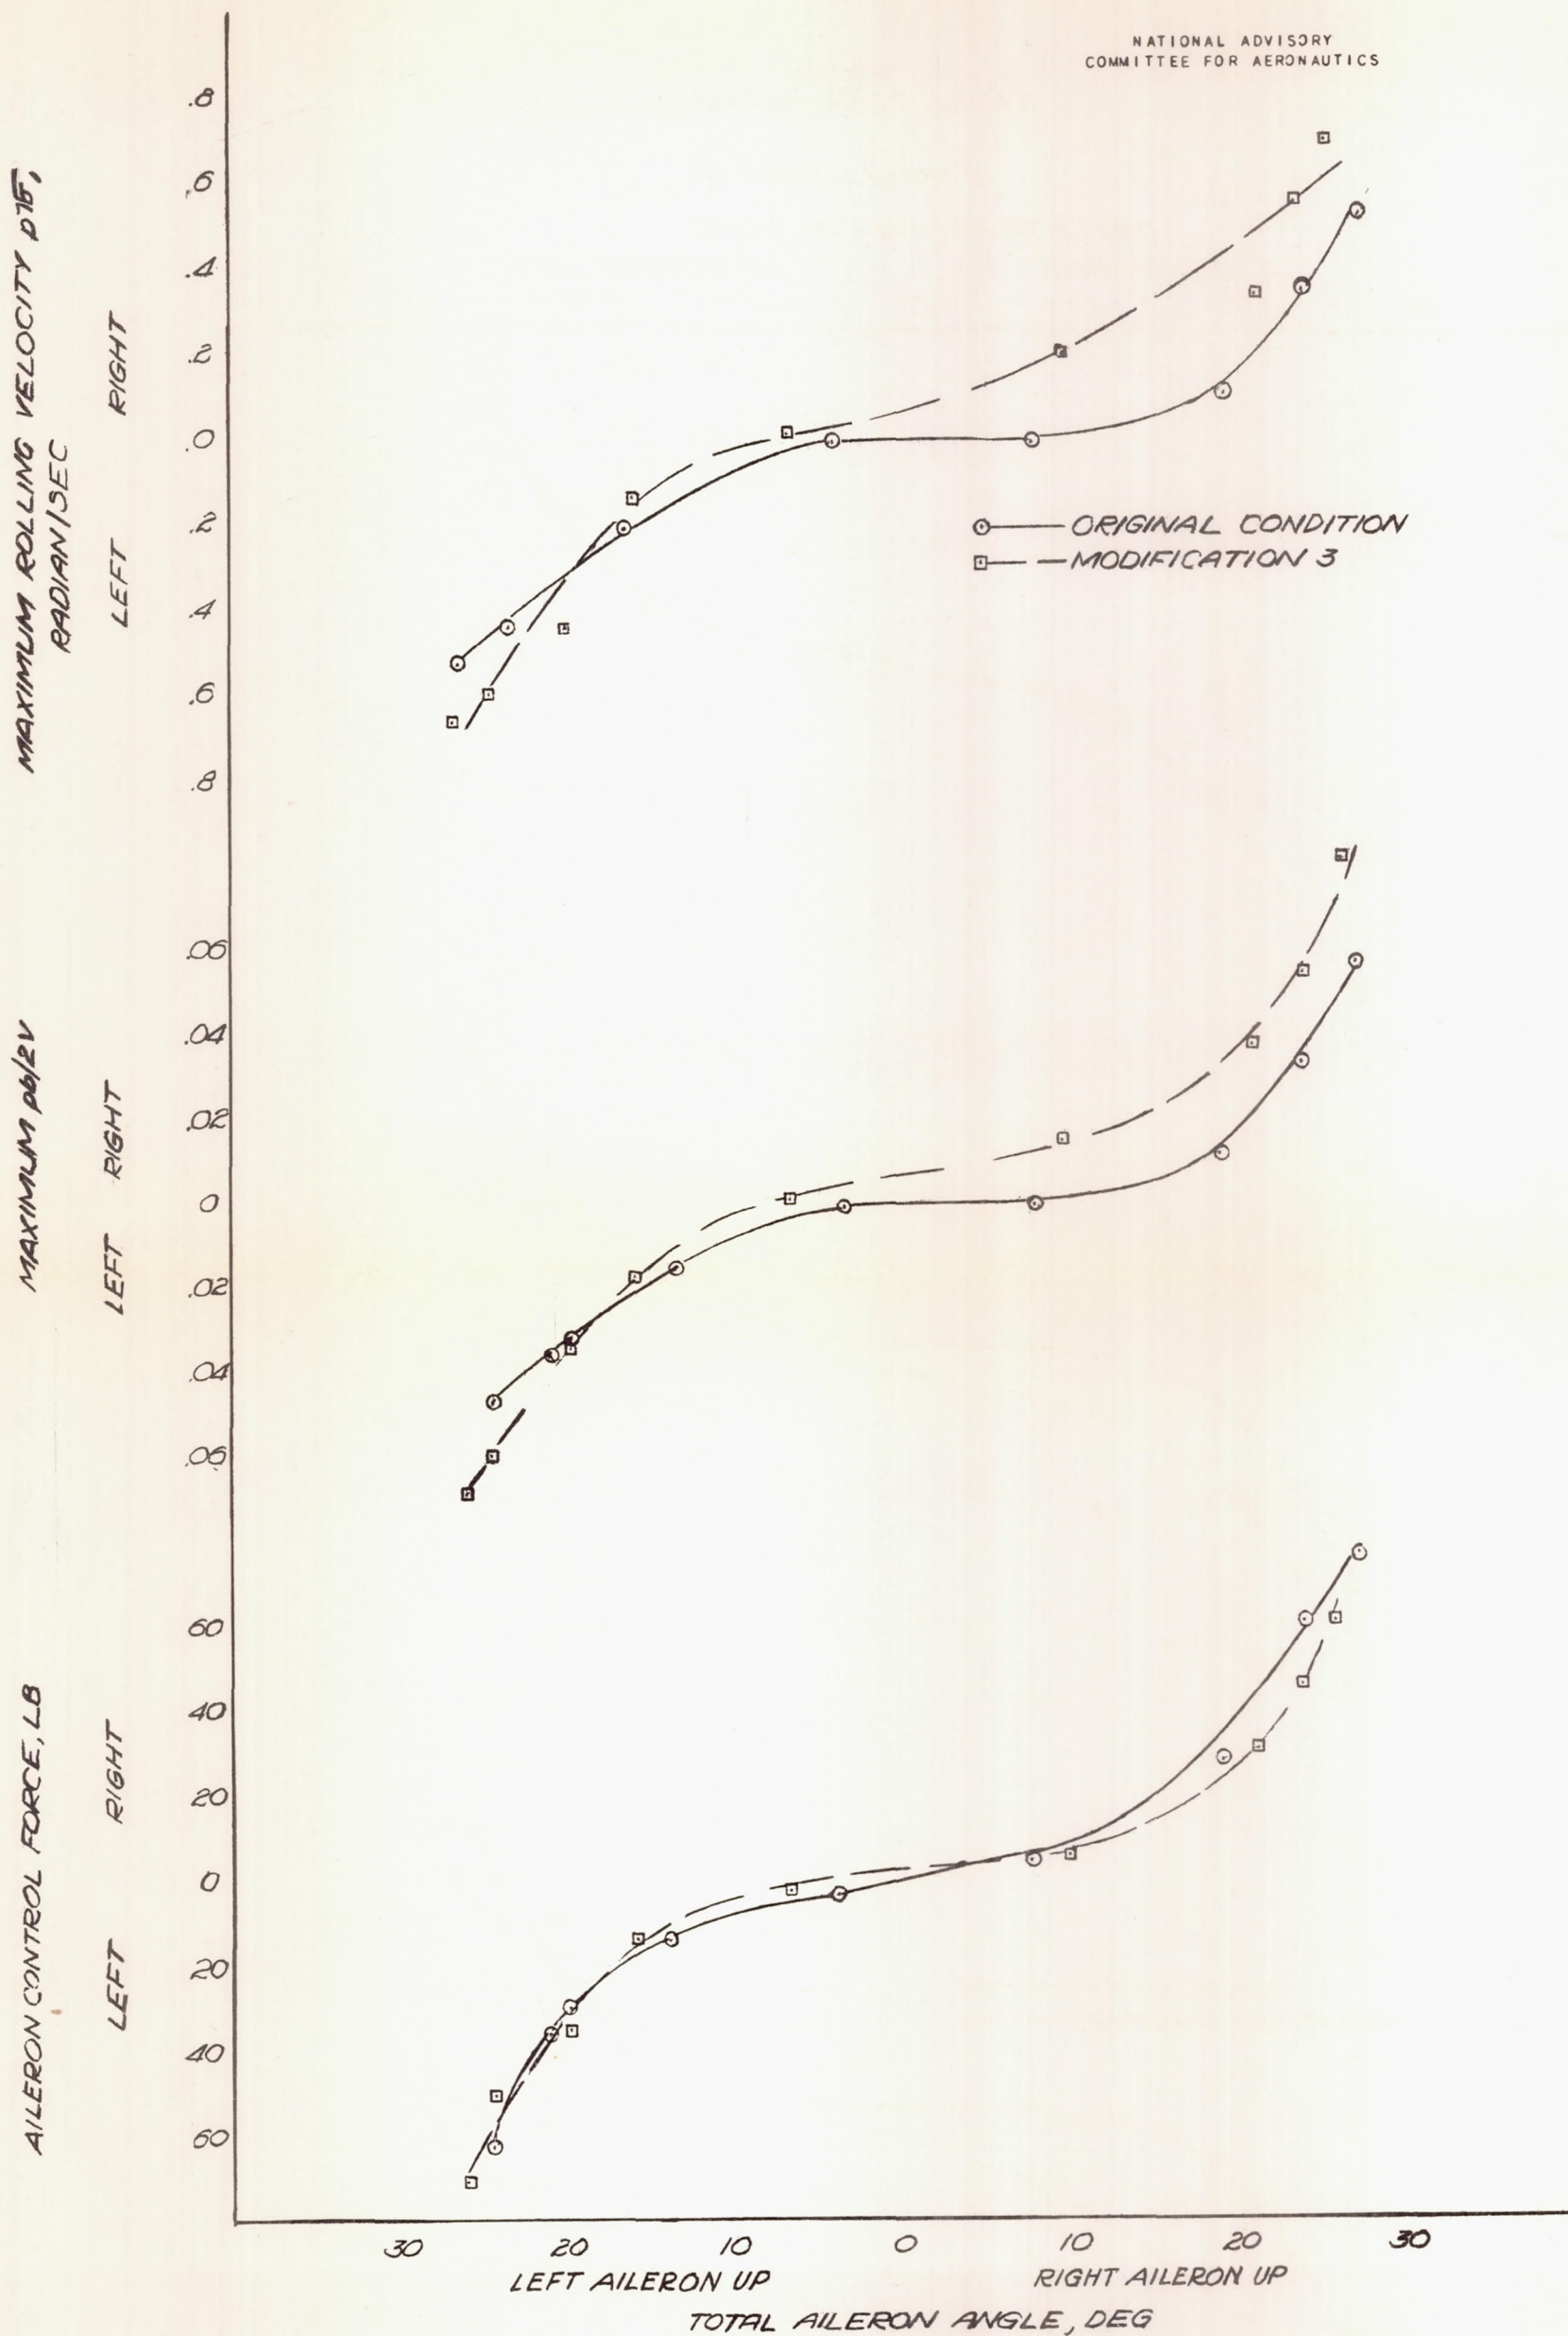
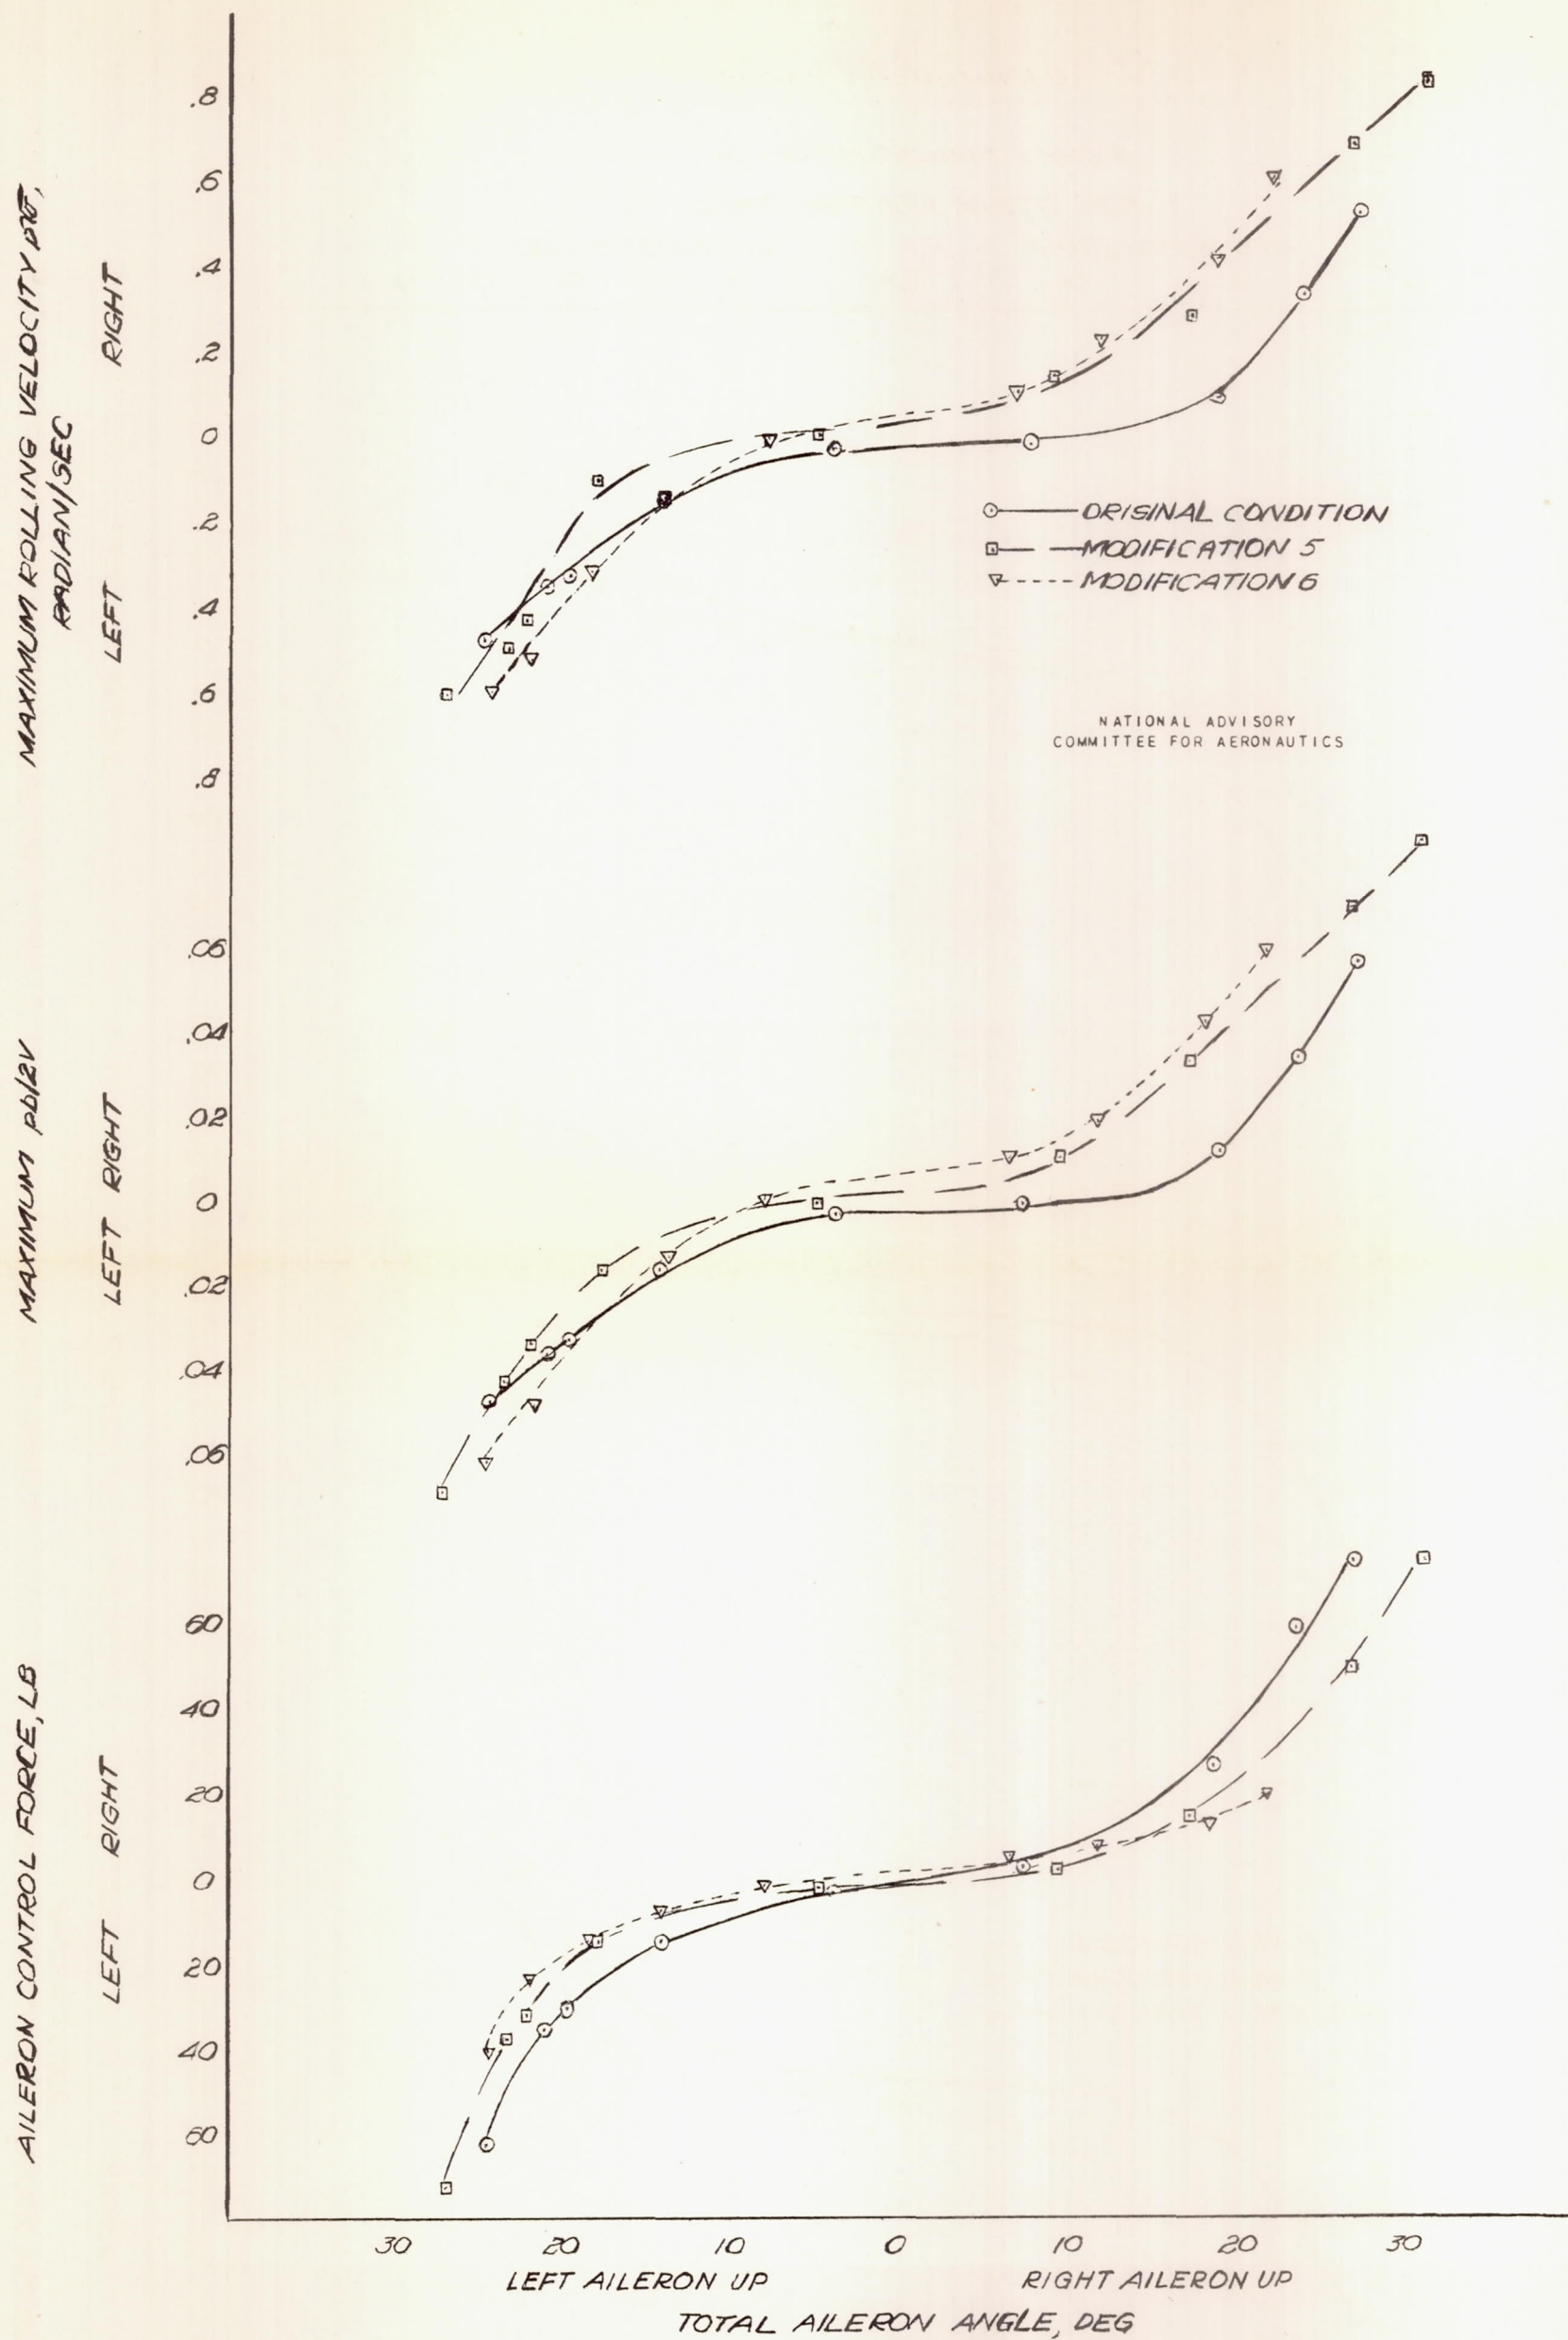
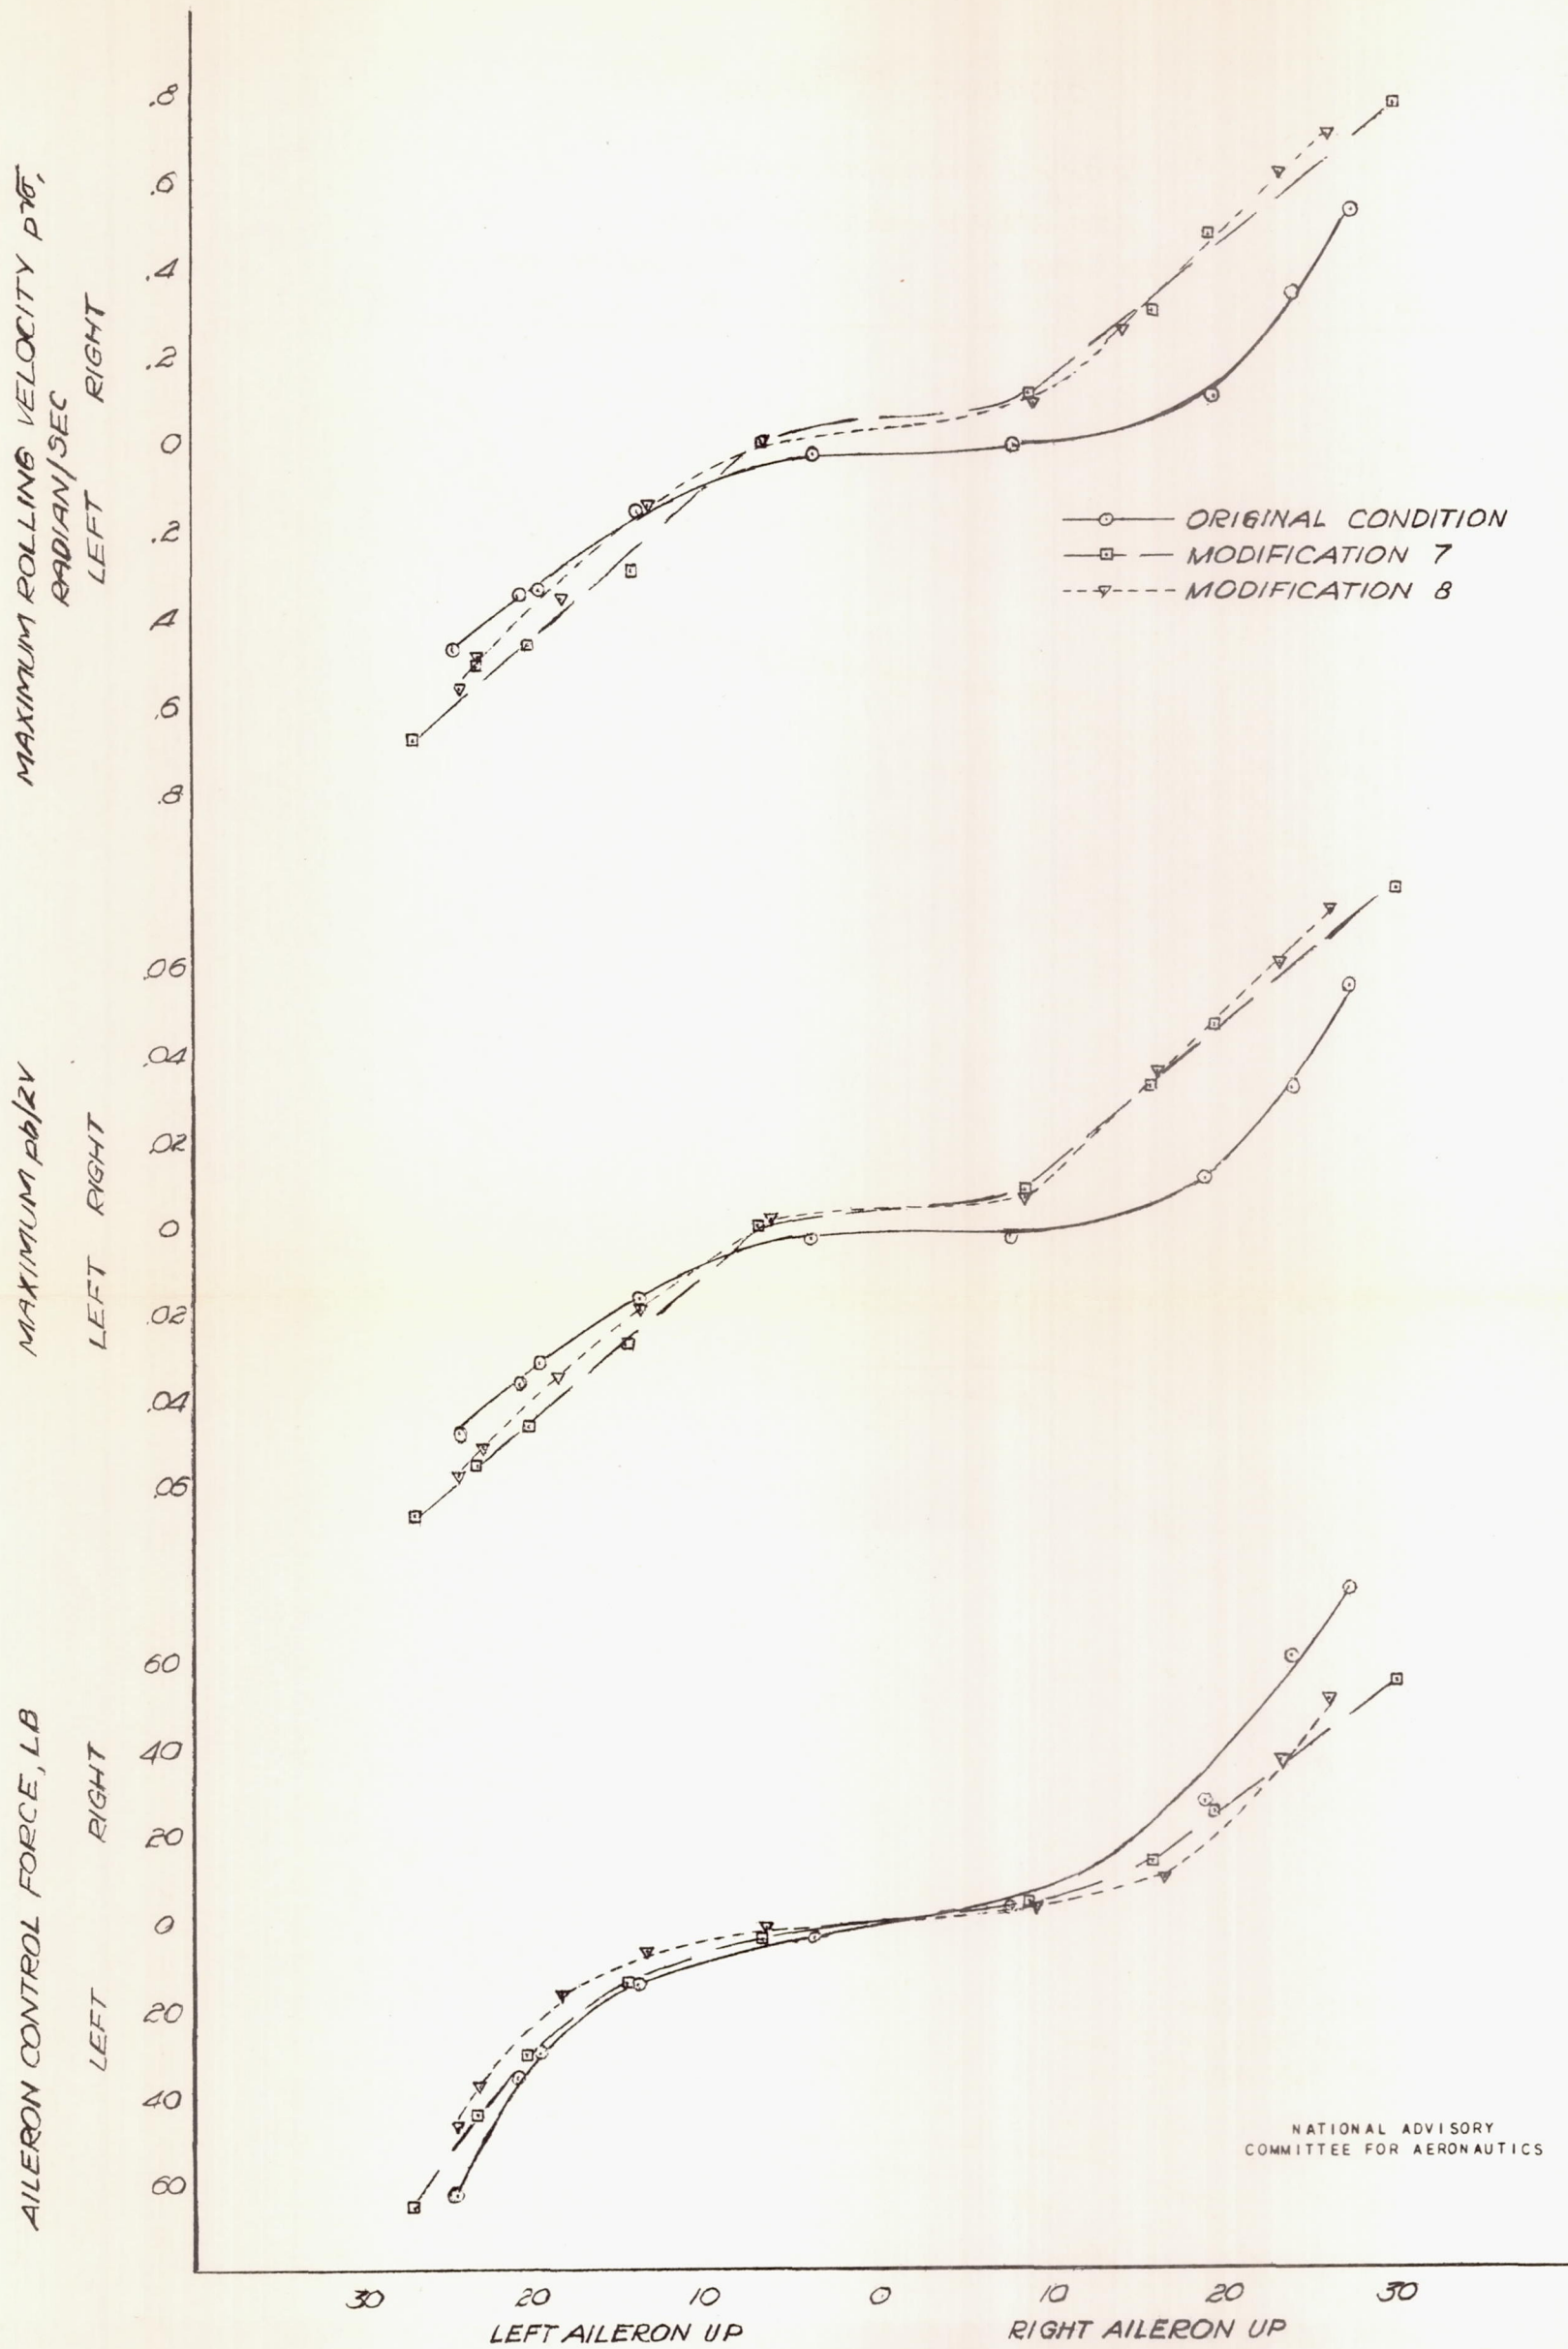
FIGURE 38 . - AILERON CONTROL CHARACTERISTICS WITH MODIFIED AILERONS, RATED POWER, FLAPS DOWN, 122 MILES PER HOUR.

FIGURE 38.-CONTINUED

FIGURE 38-CONCLUDED

Modification 3.— The vane axis of rotation in each wing was lowered in an attempt to improve the air flow over the vanes and increase their control-force-reduction effectiveness. The vanes were set at the same nose-up angle as in the original condition. Thus, from a comparison of the curves for this modification with those of the original condition (figs. 36(b), 37(b), and 38(b)), it may be seen that this adjustment had no marked effect on the lateral-control characteristics except in the flaps-down condition (fig. 38(b)), the curves being

practically coincidental with those for the original condition. Thus, the effectiveness of the vanes appeared to be independent of the position of their axis of rotation.

Modification 8.— For the same condition as in modification 7 but with the aileron upper-surface slots open, the control forces were lowered slightly, as shown in figures 36(d), 37(d), and 38(d), over those of modification 7.

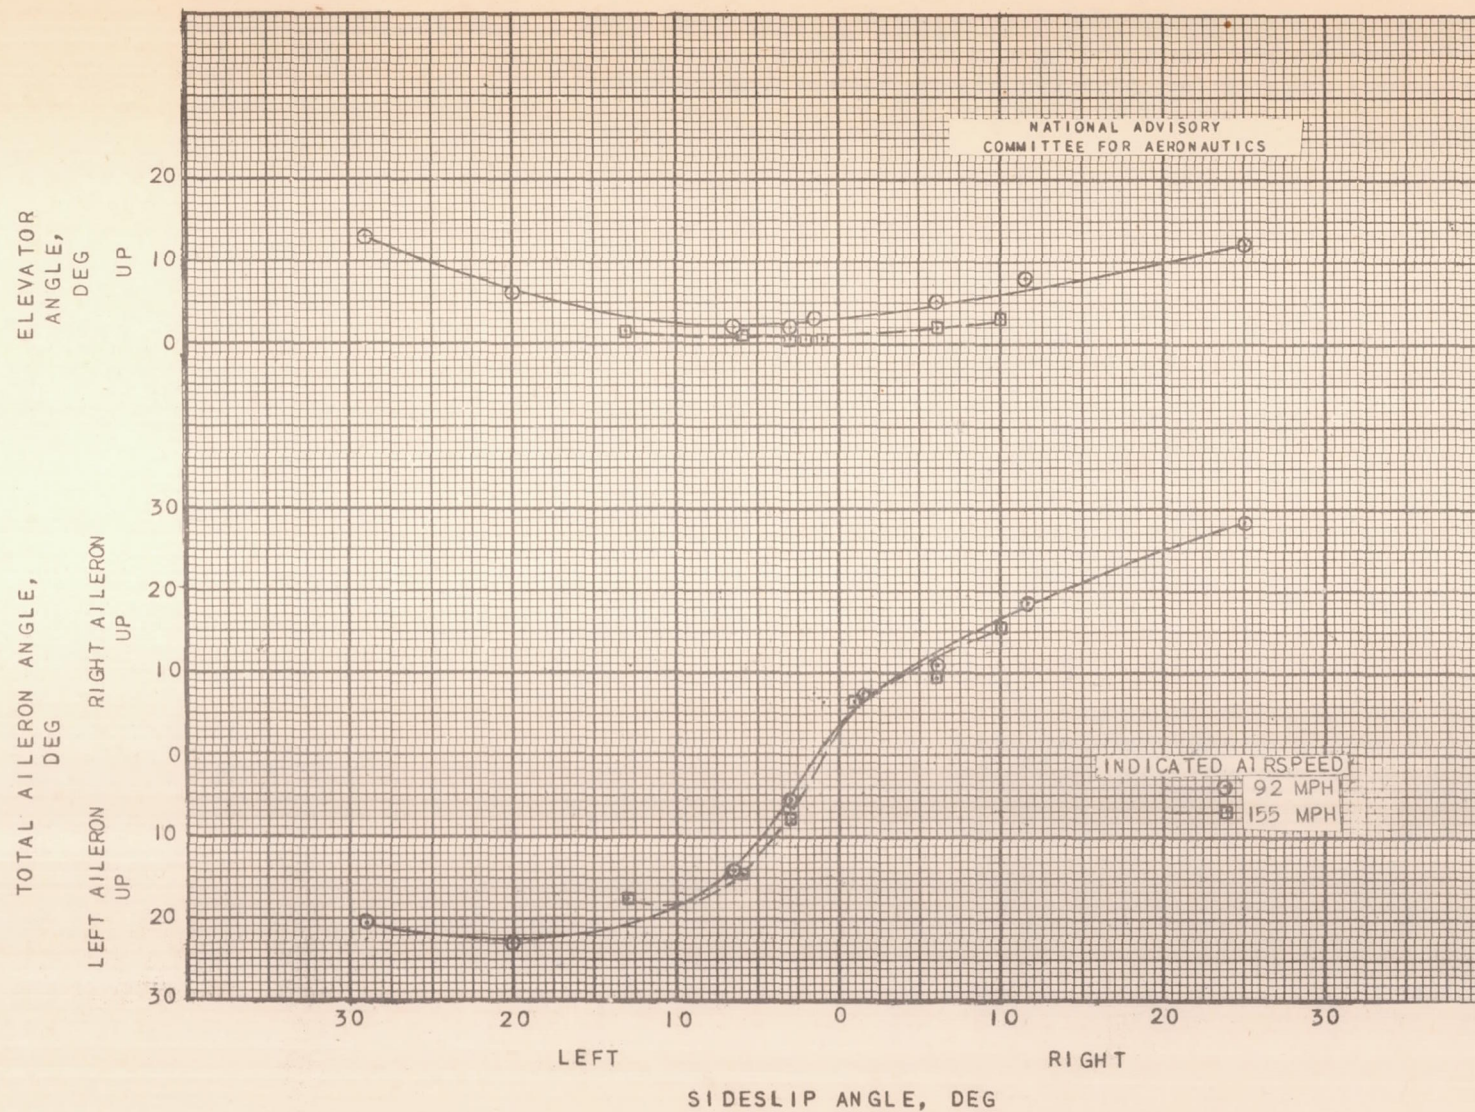
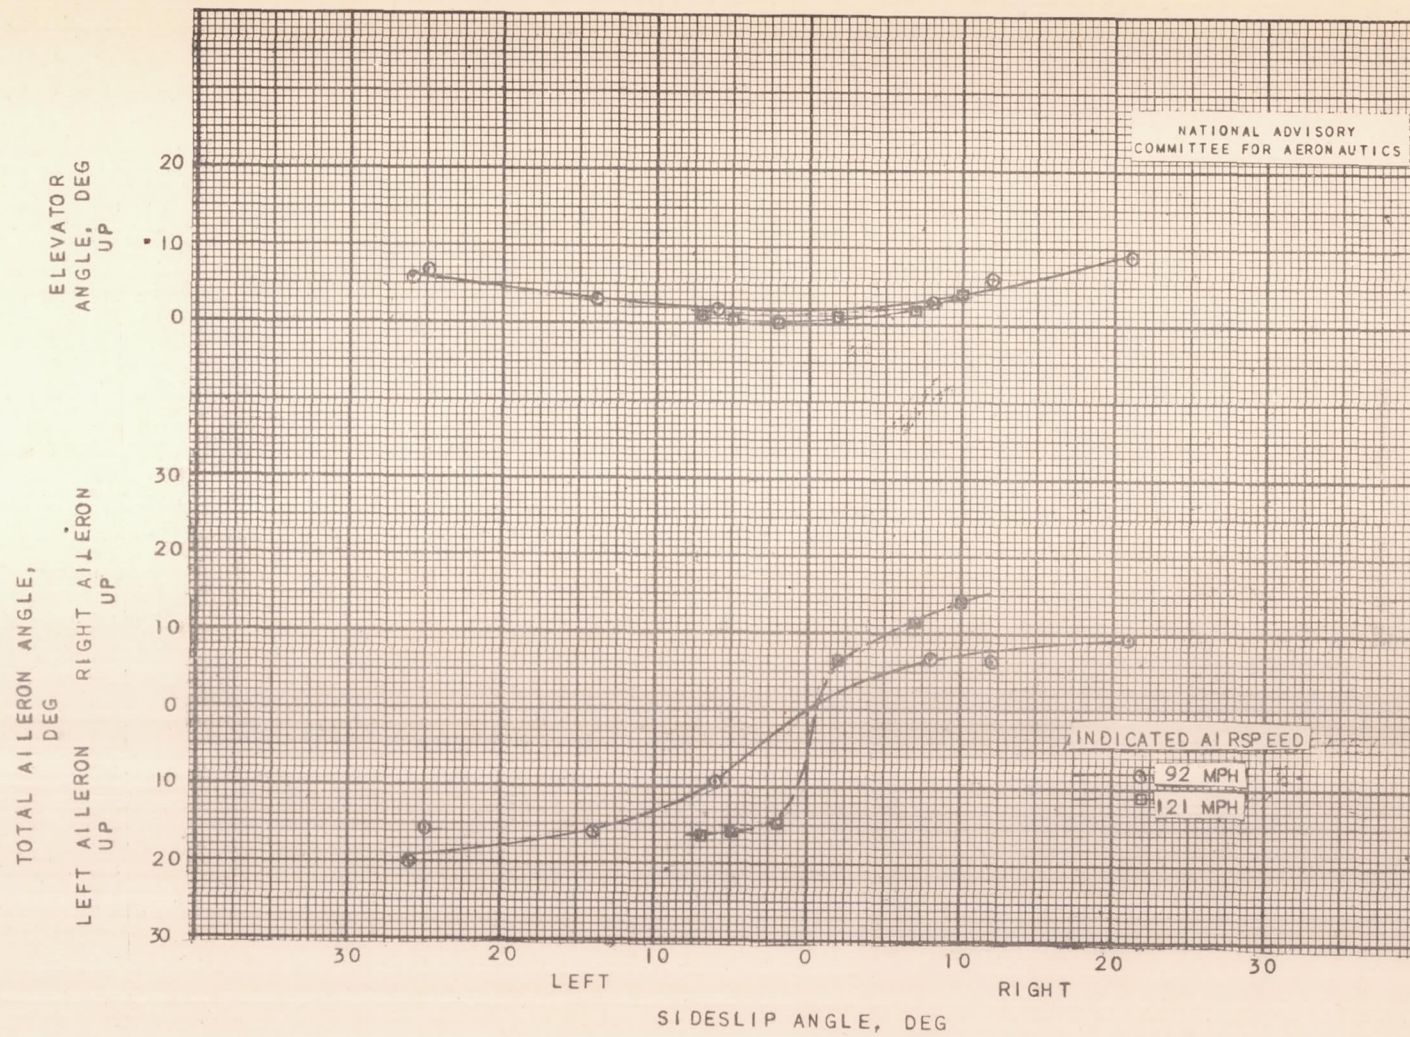
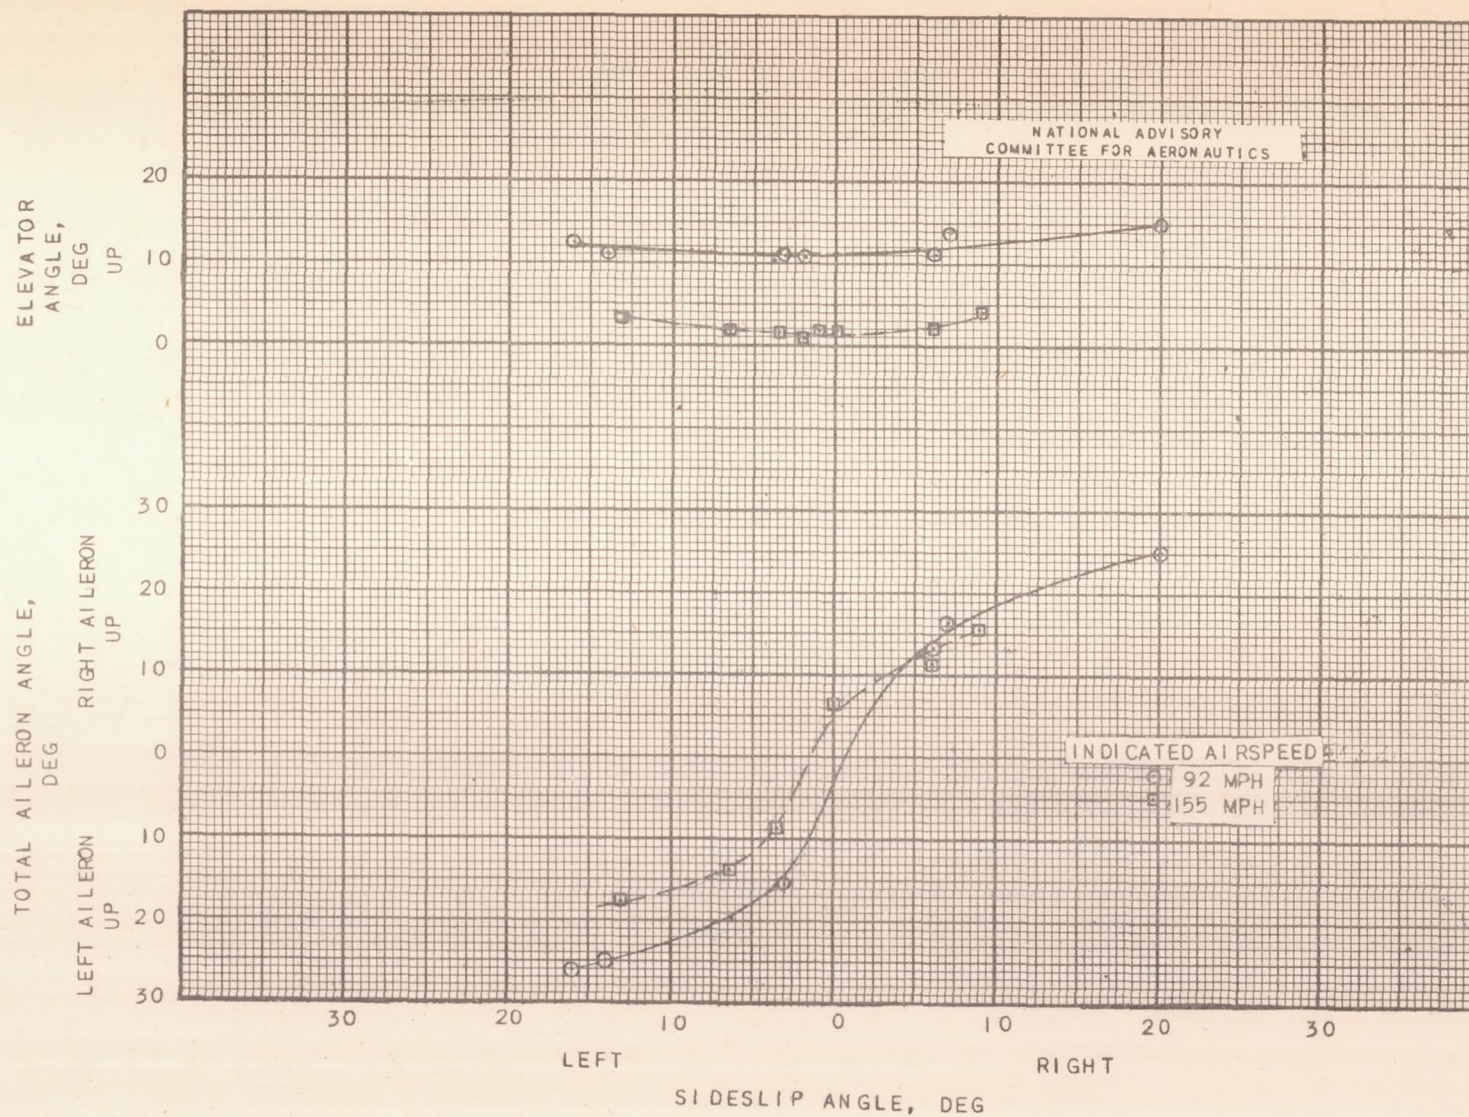
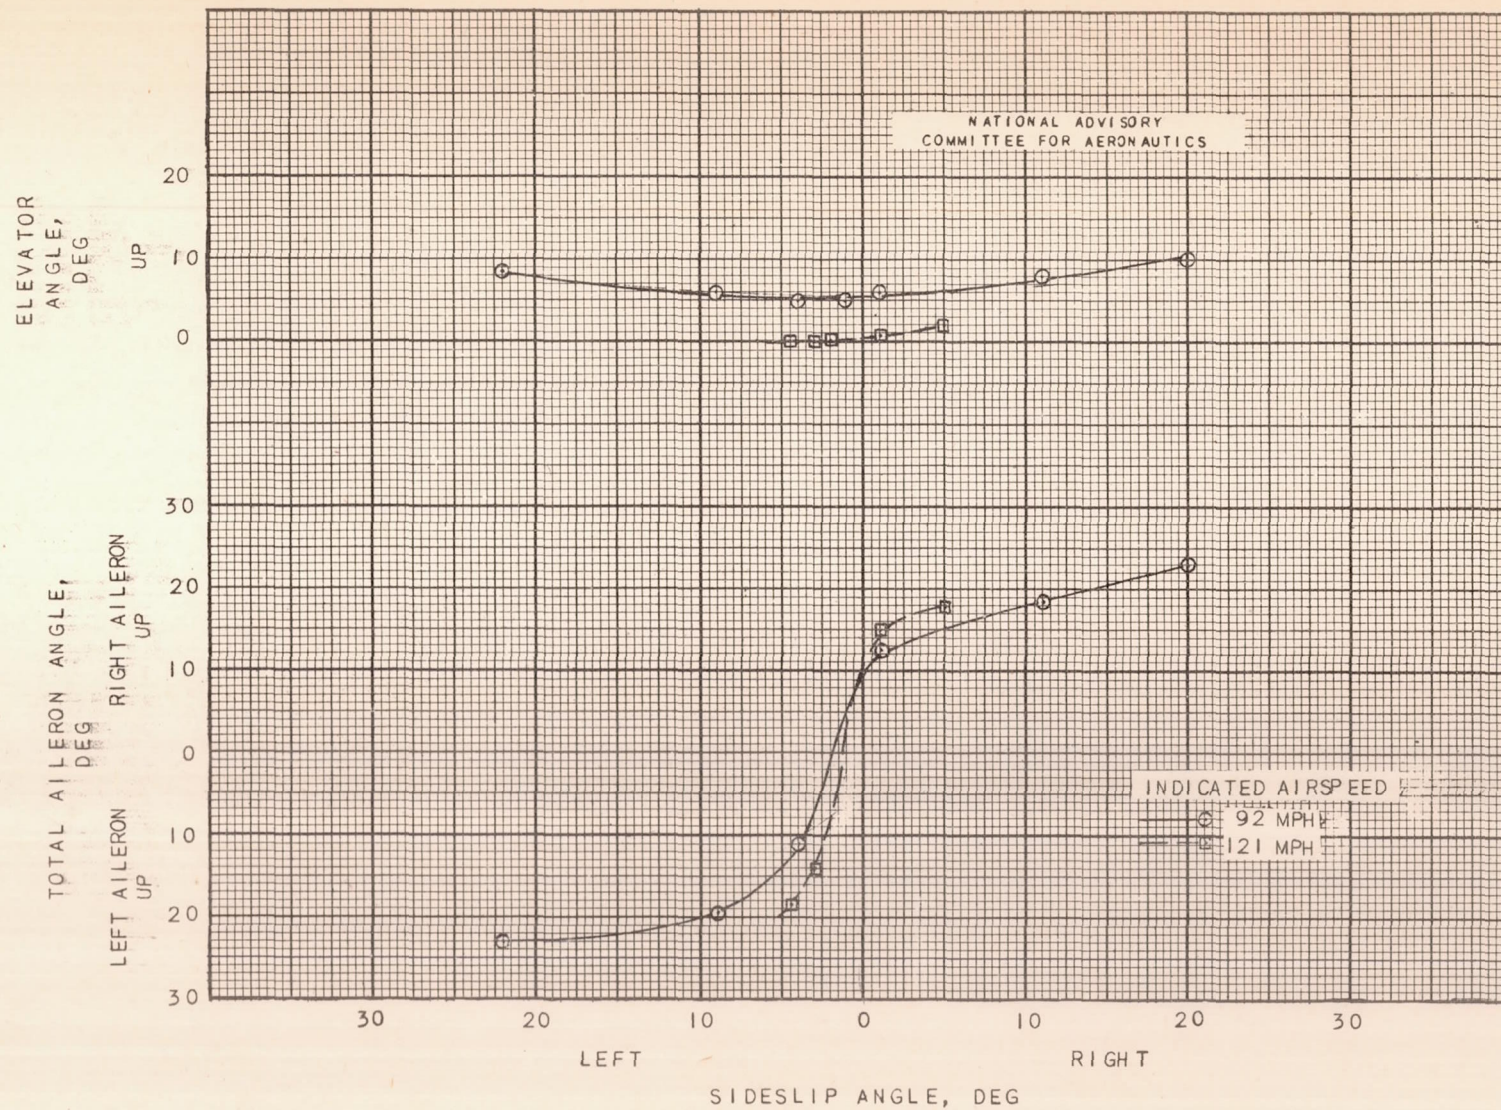
FIGURE 39. - CHARACTERISTICS IN STEADY SIDESLIPS, RATED POWER, FLAPS UP.

FIGURE 40. - CHARACTERISTICS IN STEADY SIDESLIPS, RATED POWER, FLAPS DOWN.

FIGURE 41. - CHARACTERISTICS IN STEADY SIDESLIPS, POWER OFF, FLAPS UP.

FIGURE 42. - CHARACTERISTICS IN STEADY SIDESLIPS, POWER OFF, FLAPS DOWN.

From the figures it is seen that the variation of aileron angle with sideslip angle is progressive and fairly smooth on either side of neutral aileron angle for all flight conditions investigated. Although no control-force records were taken, it is probable that the curves relating aileron control force with sideslip angle would have a flat portion near zero control force as in the case of aileron control characteristics tending to produce poor centering characteristics.
